B.-D. Hahn, D.-S. Park, J.-J. Choi, J. Ryu, W.-H. Yoon, K.-H. Kim, C. Park, and H.-E. Kim, "Dense Nanostructured Hydroxyapatite Coating on Titanium by Aerosol Deposition," *J. Am. Ceram. Soc.*, **92** [3] 683-87 (2009).

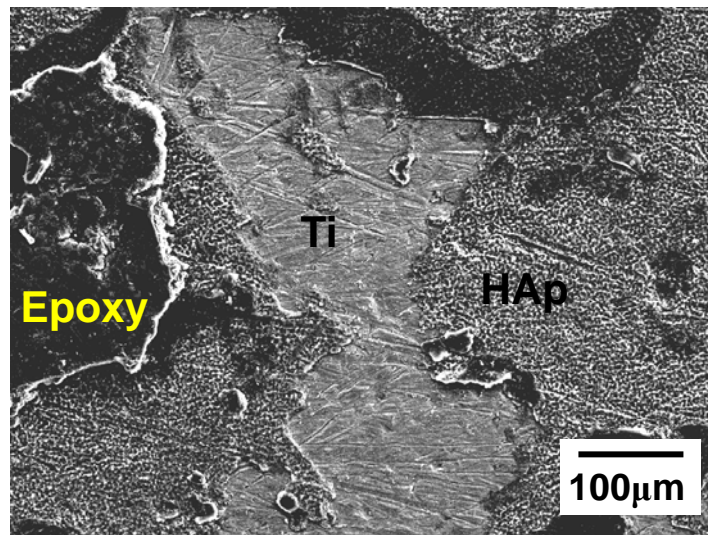
Fig. 5 Scanning electron microscopy micrograph of fracture surface of HA sample after tensile adhesion strength test; the failure occurred in epoxy, between the HAp coating and epoxy, and between Ti substrate and the HAp coating.
